Special Report 77-18

INSTALLATION OF LOOSE-LAID INVERTED ROOF SYSTEM AT FORT WAINWRIGHT, ALASKA

David Schaefer

June 1977

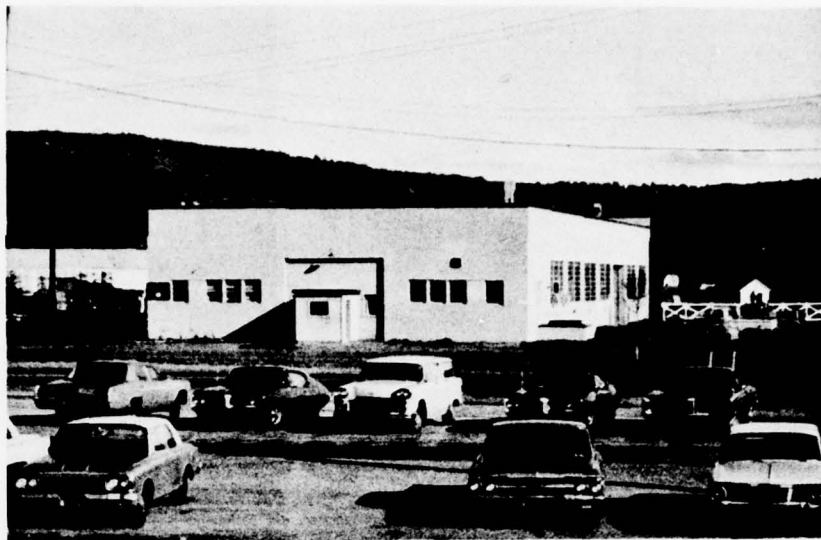
1. Building 1053, Ft. Wainwright, Alaska. Motor vehicle repair and warm storage.

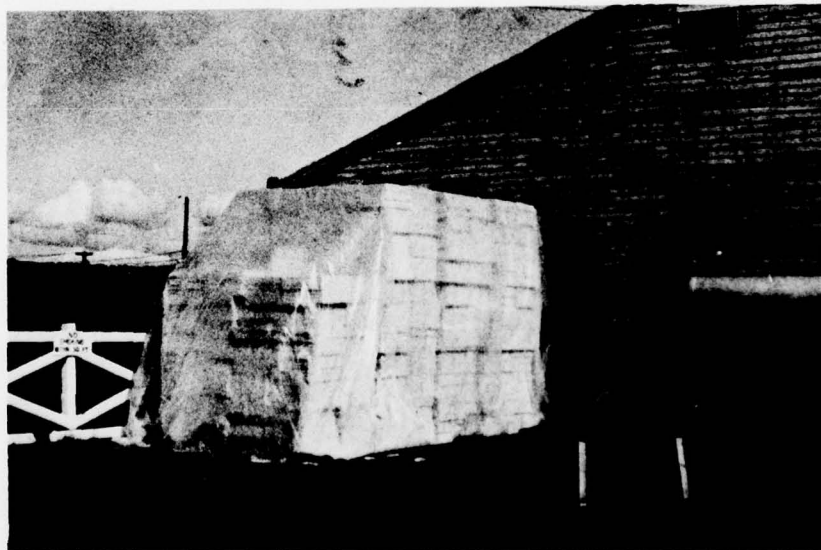
2. Stockpiled materials for loose-laid inverted roofing system.

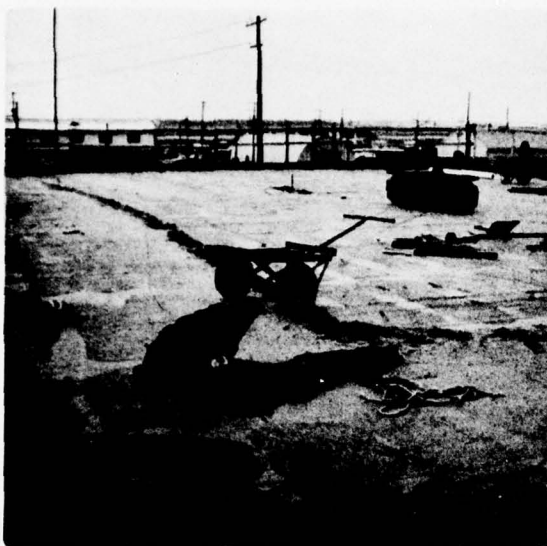
3. Contractor began removal of existing BUR on 6 July 1971.

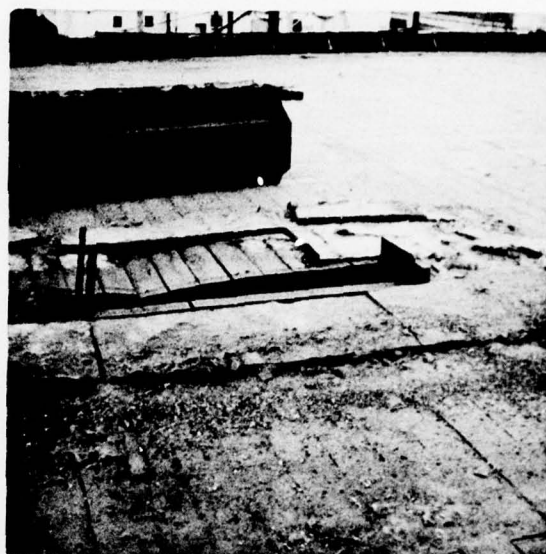
4. Metal deck, insulation and metal deck at ridge vent.

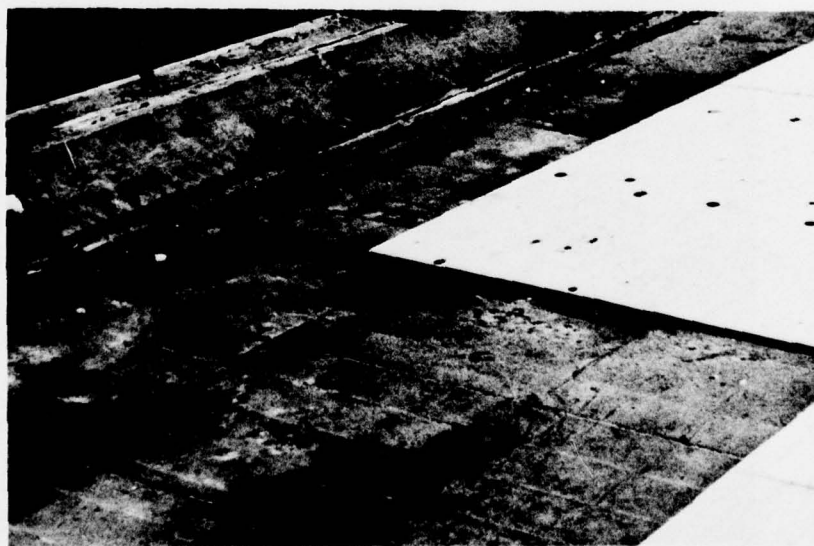
Upon removal of the existing roof, it was found that the steel deck had rusted in numerous places. This was especially evident in areas of high humidity where portions of the deck had rusted through. The insulating board was completely water soaked even though the built-up roofing (BUR) membrane appeared to be in fair shape.

5. Condition of metal deck after stripping existing BUR. Note that the corrosion has penetrated the steel deck.

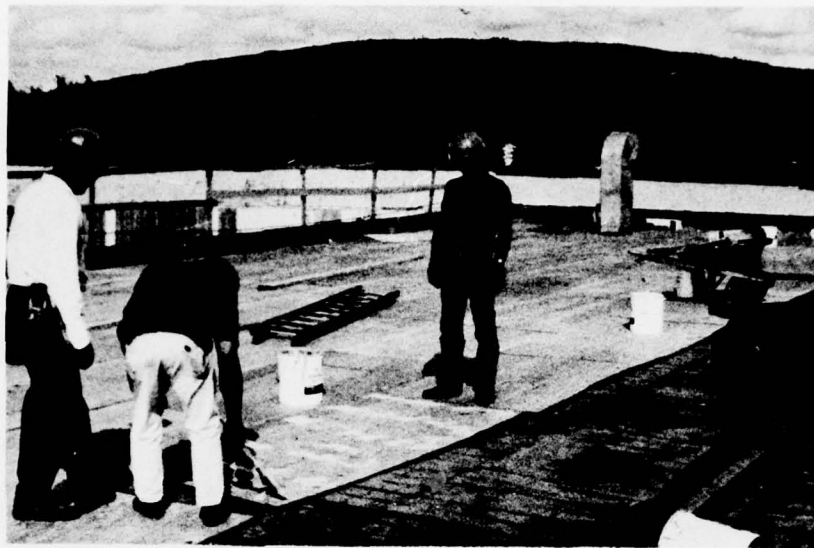
6. Application of 1/2 in. plywood sheathing to prepared metal deck. Plywood was glued to deck.

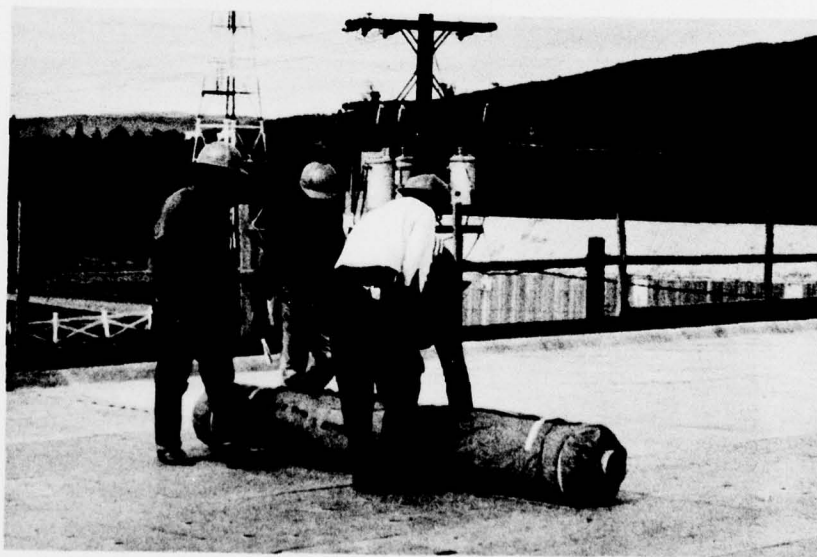
7. Rolling butyl rubber membrane on plywood deck.

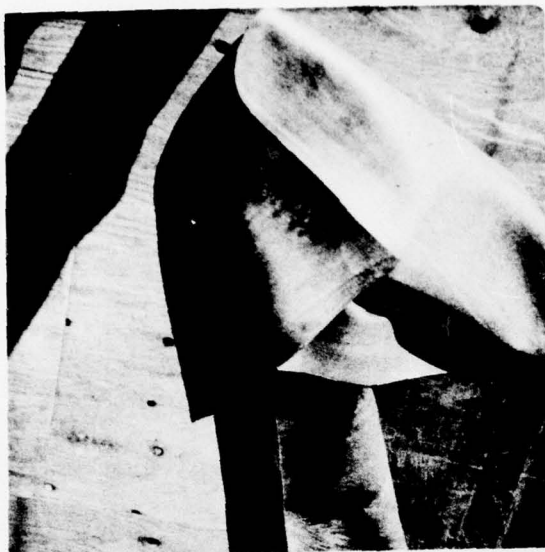
8. Close-up view of butyl rubber membrane.

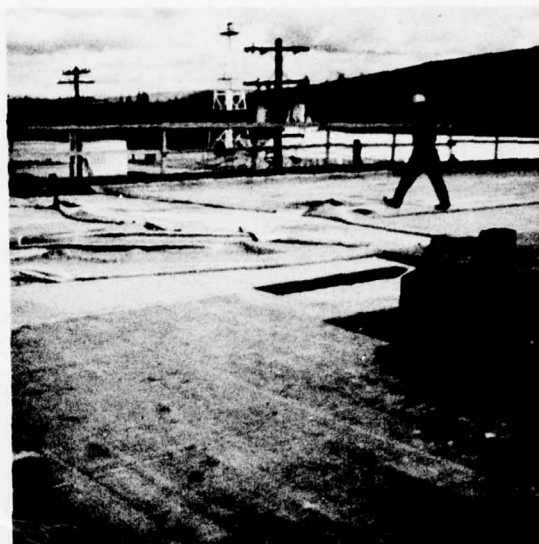
9. Placement of the butyl rubber membrane on the plywood deck. The placement took 3 hours.

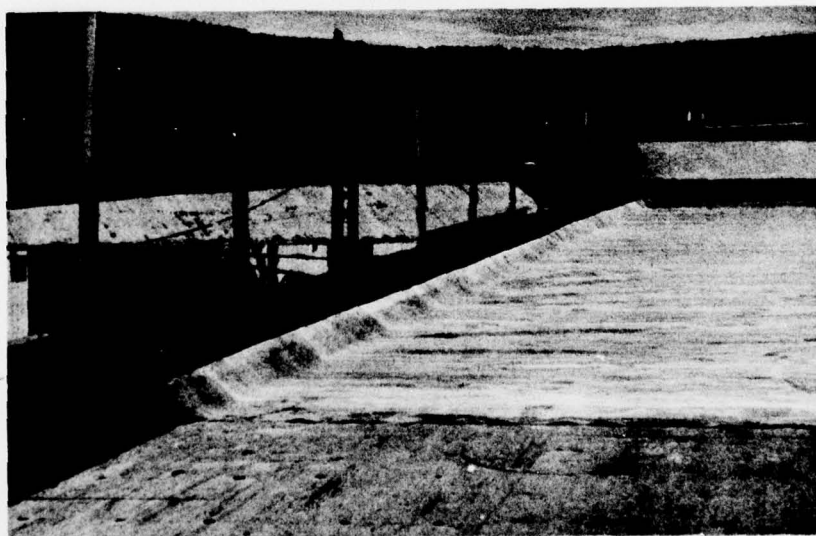
10. Membrane at the edge of the roof.

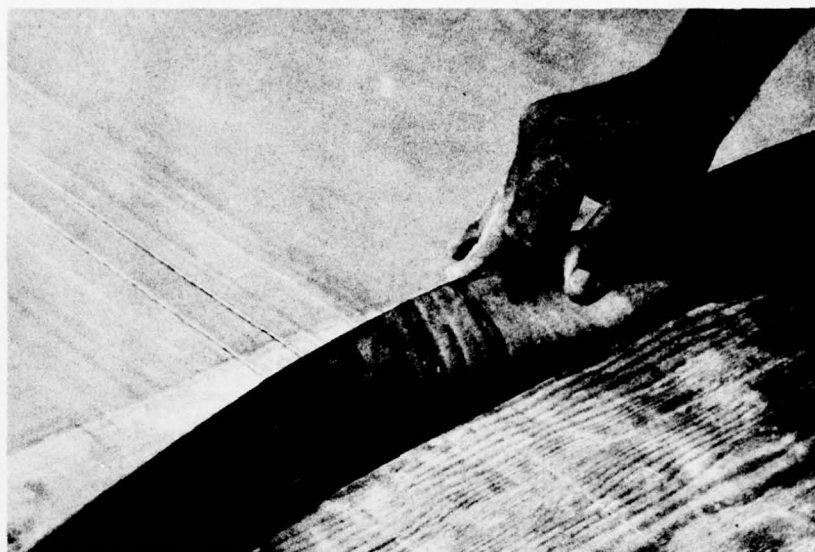
11. Close up of membrane showing factory splice.

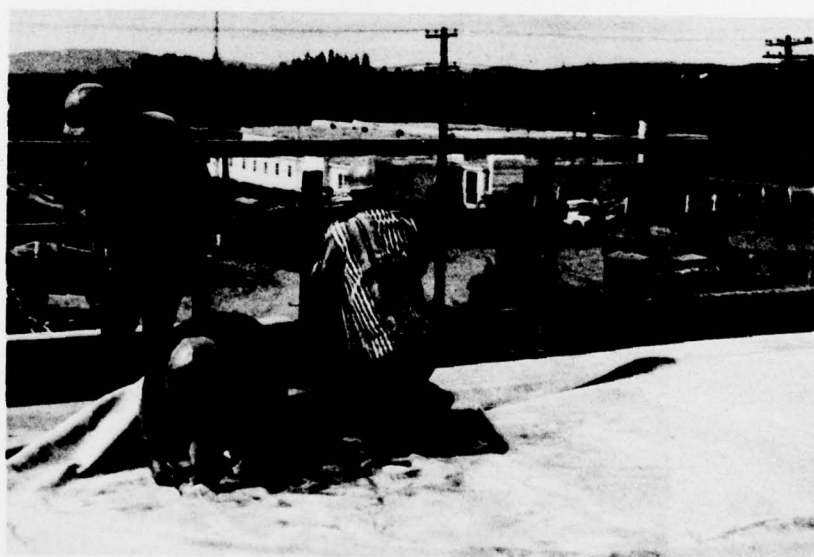
12. Cutting membrane for roof penetrations.

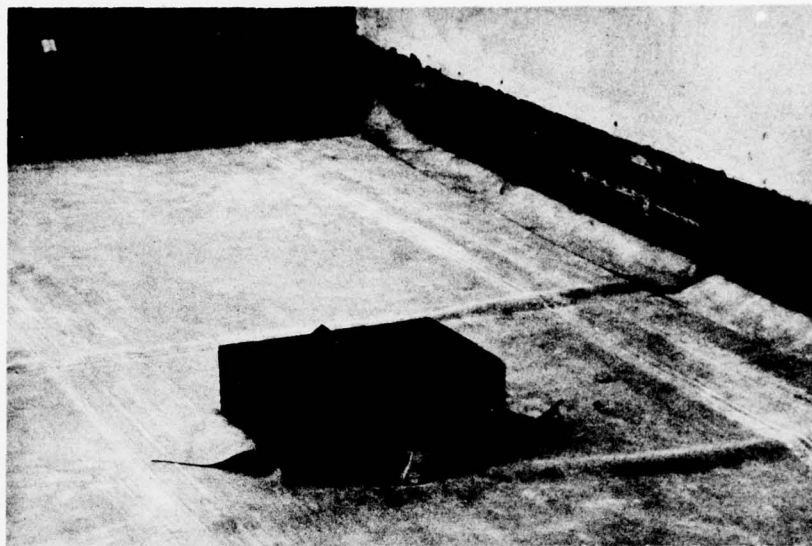
13. Duct penetration.

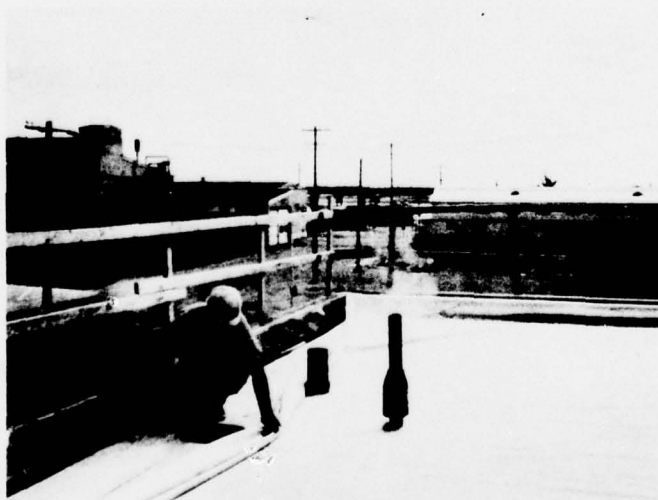
14. Exhaust stack and waste vent penetrations.

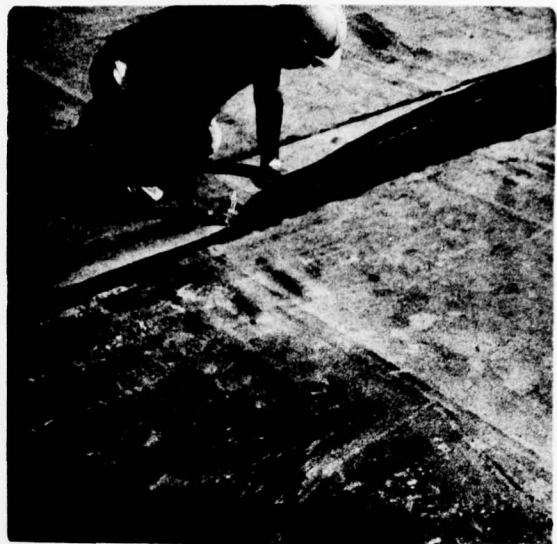
16. Polystyrene laid over the membrane and temporarily held with pavers.

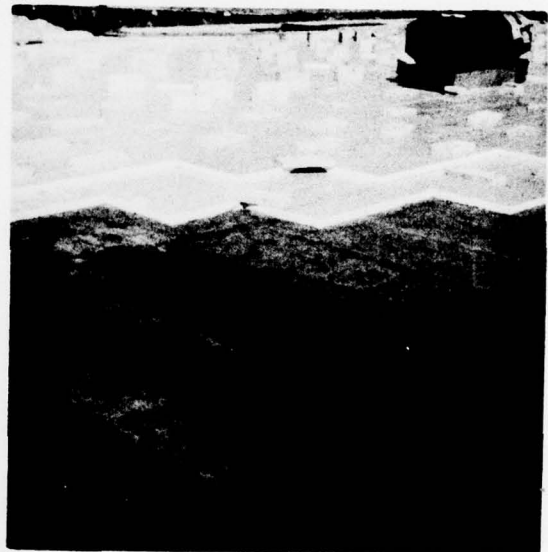
17. Portion of roof showing finished concrete paver placement.
